Manhole Inspection Summary

Manhole # S51A__032MH

Location Address: **rear 2718 jefferson st**

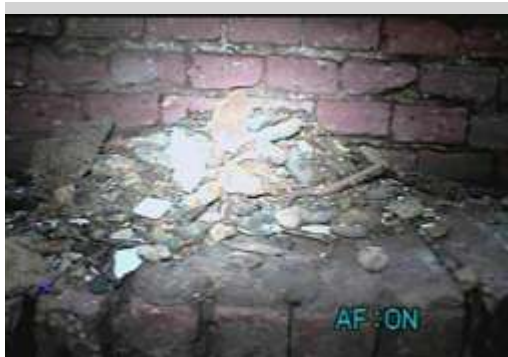
Miscellaneous

bench debris

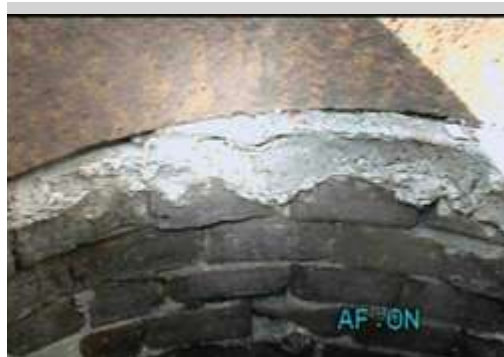
Misc-1

frame adjustment

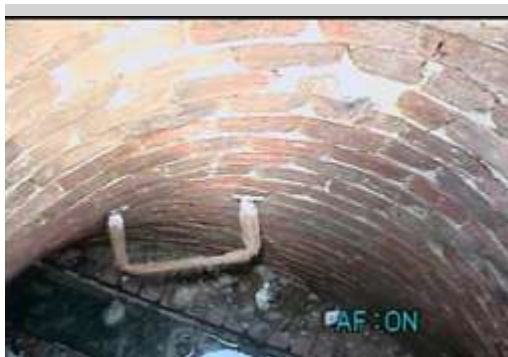
Defect 3

Steps Count: **2** Missing: **1** ☒ **Corroded**

missing/corroded steps

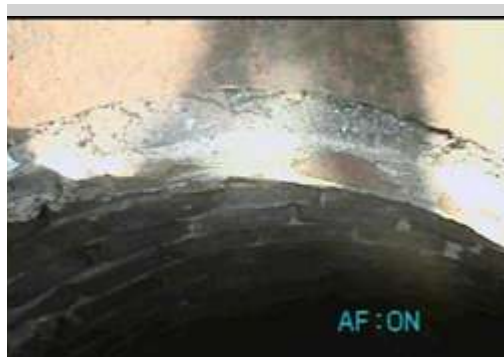
Defect 1

Frame Offset: **2** (in.) Condition: ☒ Sound ☐ Cracked ☐ Leaks

offset
